PACSystems™ RX3i

IC695ETM001

GFK-2332A
April 2005

Ethernet Interface Module

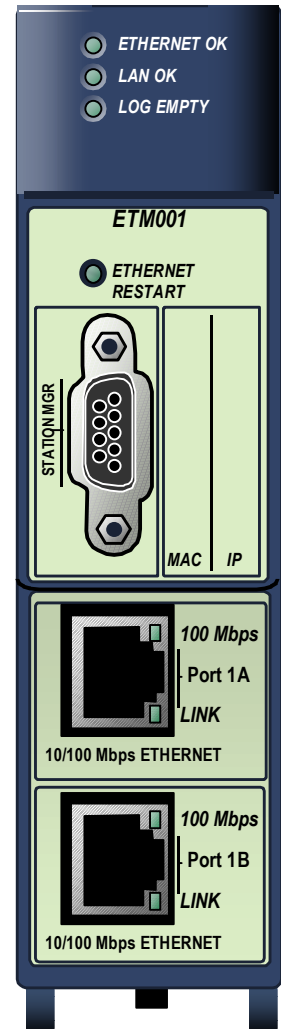
The Ethernet Interface Module, IC695ETM001, connects a PACSystems RX3i controller to an Ethernet network. It enables the RX3i controller to communicate with other PACSystems equipment and with Series 90 and VersaMax controllers. The Ethernet Interface provides TCP/IP communications with other PLCs, host computers running the Host Communications Toolkit or programmer software, and computers running the TCP/IP version of the programming software. These communications use the GE Fanuc SRTP and Ethernet Global Data (EGD) protocols over a four-layer TCP/IP (Internet) stack.

- Built-in Station Manager for on-line supervisory access to the Ethernet Interface. Dedicated Station Manager port.
- Two auto-sensing 10Base T / 100Base TX RJ-45 shielded twisted-pair Ethernet ports for direct connection to either a 10BaseT or 100BaseTX IEEE 802.3 network without an external transceiver. There is only one interface to the network (only one Ethernet MAC address and only one IP address).

- Internal network switch with Auto negotiate, Sense, Speed, and crossover detection.
- Recessed Ethernet Restart pushbutton to manually restart the Ethernet firmware without power cycling the system.
